Landfill Gas Monitoring Report

EPL 13366

August 2022

Bowral Landfill Pty Ltd engaged 4Pillars Environmental Consulting Pty Ltd (4Pillars) to conduct landfill gas monitoring for Bowral Waste Centre (8 Kiama Street, Bowral, NSW – the Site), to ensure compliance with Environment Protection Licence (EPL) 13366.

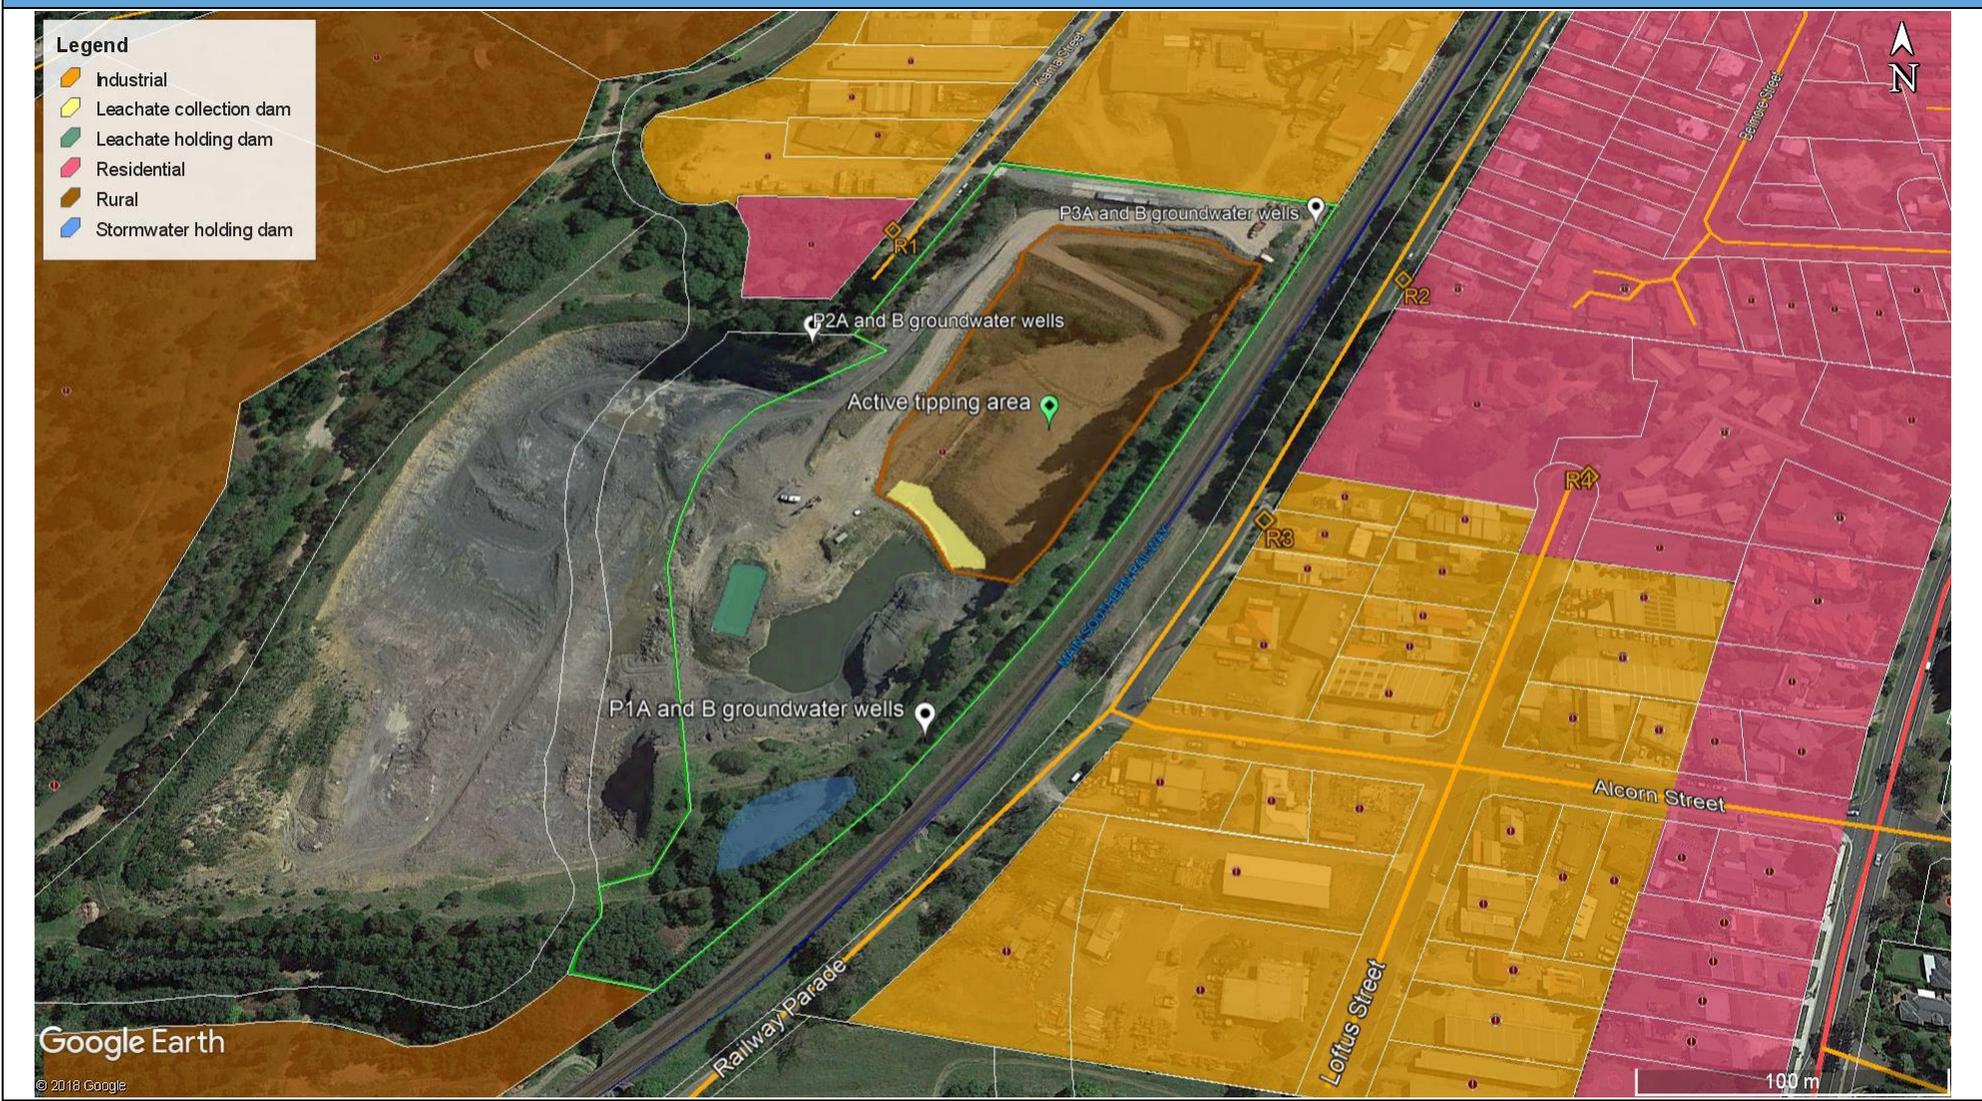
Drawn by:	JH	Date	25/05/2017	Report reference:	20190601BOW-02	Key:	Orange points: Receivers Green line: Site boundary
Reviewed by:	TN	Date	29/07/21	Image source:	Google Earth Pro		Dark blue line: railway Other polygons: as per legend

Figure 1: Simulated oblique image showing Site layout, key features and nearby sensitive receivers.

The subject Site is 8 Kiama Street, Bowral, NSW, 2576 – part lots 13 and 14 DP1022146. The landfill site is located within the Wingecarribee Shire local government area (LGA). The landfill site falls within the IN1 (general industrial) development zone under the *Wingecarribee Local Environment Plan 2010*. Surrounding land zoning includes IN1 and IN2 (light industrial), R3 and R2 (medium and low density residential), RU4 (primary production small lots) and RE1 (public recreation). The majority of the surrounding land uses are agricultural or industrial, such as horticulture, landscaping supply, self-contained storage, sewerage treatment, car repairs, etc. The nearest residential area is medium density and occurs immediately to the east of the Site, along Railway Parade. Residential and business receivers are located to the east and west of the Site (refer Figure 1).

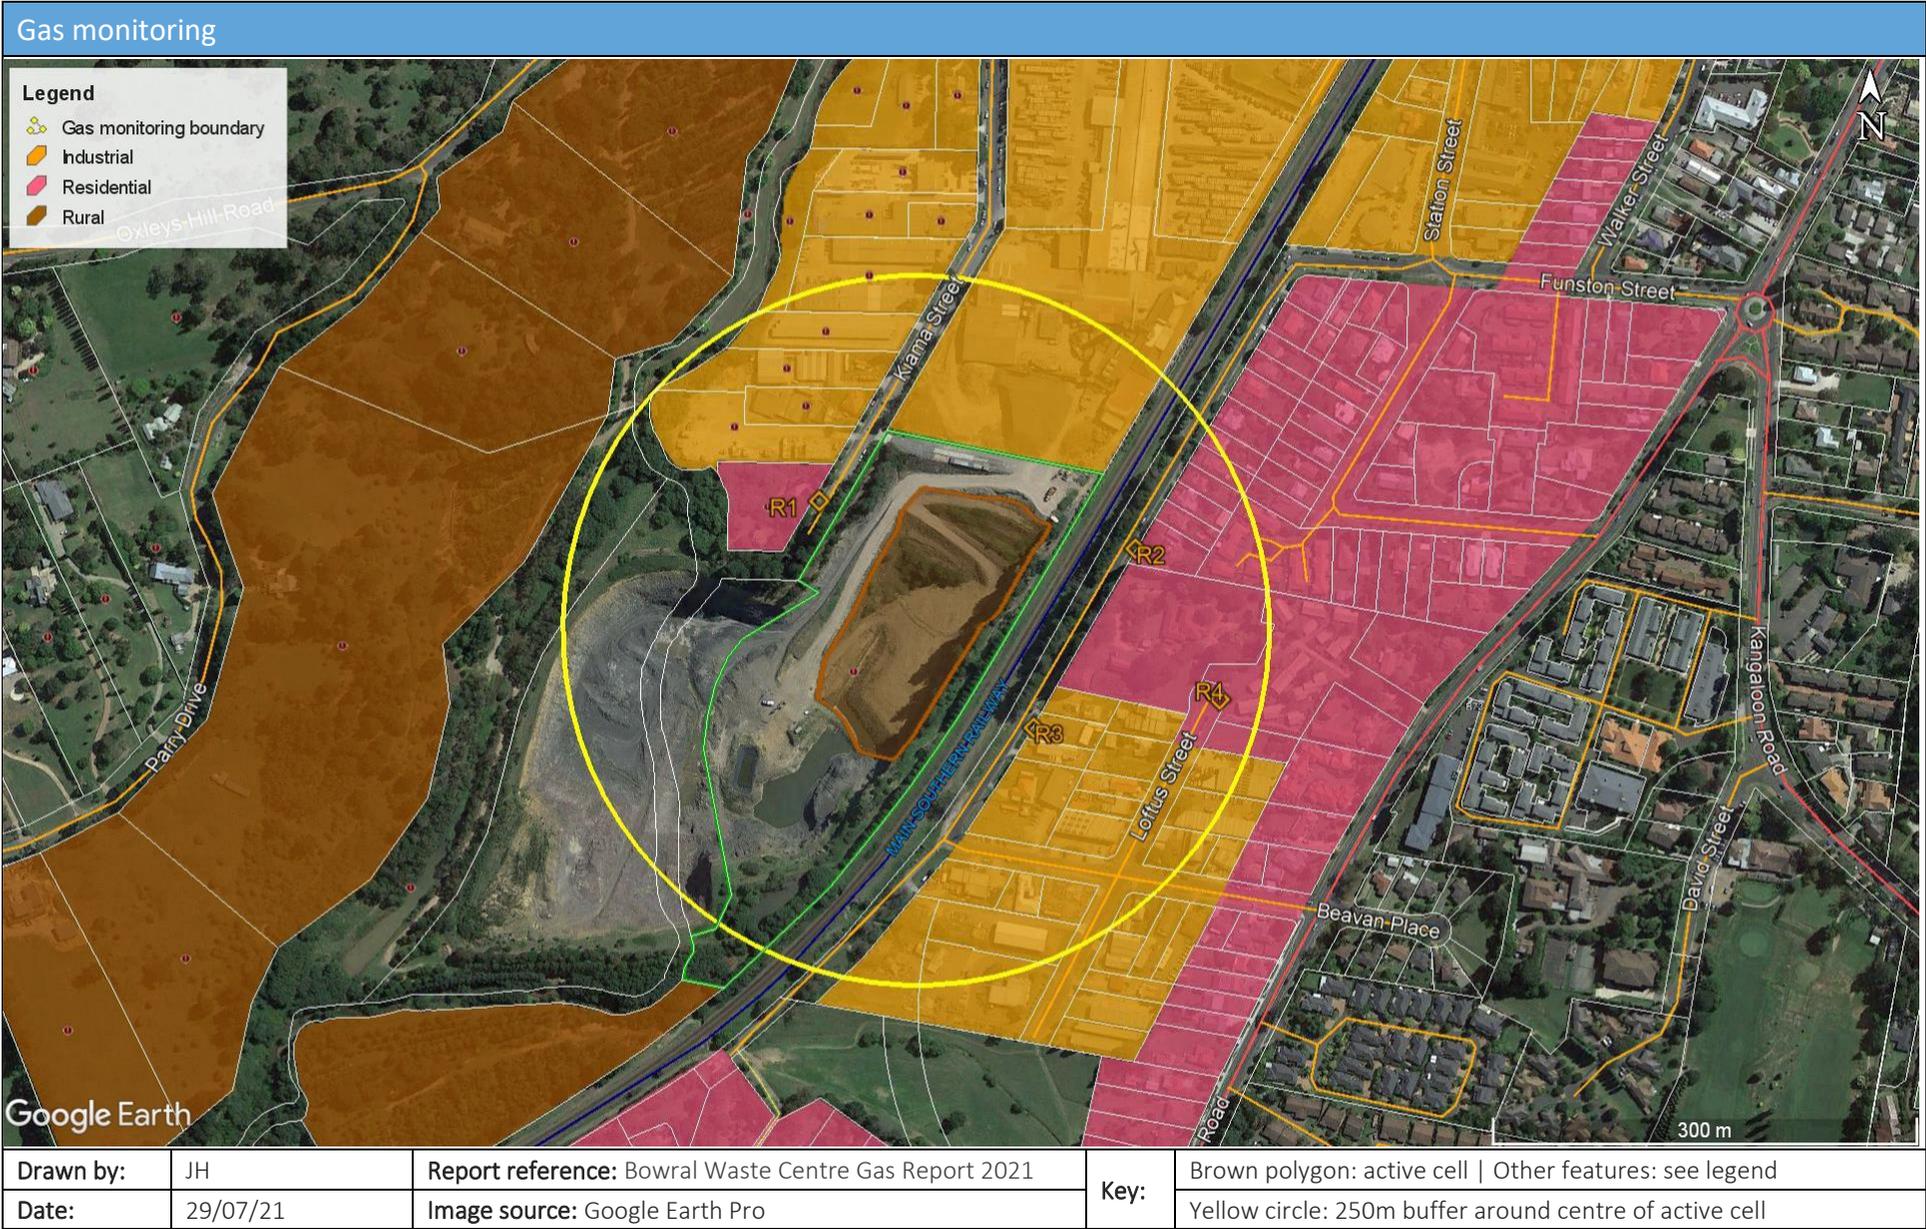
Figure 2: Figure showing all properties with buildings within a 250 m radius of deposited waste. The purple and light green lots fall within the scope of gas monitoring.

Neither intermediate nor final cover was placed in the landfill on the day of monitoring; therefore, landfill gas measurements were not taken on the active cell. As per the Site's EPL, the measurement of methane in buildings within 250 m of deposited waste (see Figure 2) was undertaken.
